31 Preservation Briefs

Technical Preservation Services
National Park Service
U.S. Department of the Interior

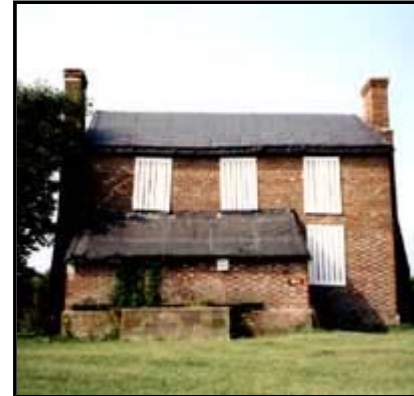
A NOTE TO OUR USERS: The web versions of the **Preservation Briefs** differ somewhat from the printed versions. Many illustrations are new, captions are simplified, illustrations are typically in color rather than black and white, and some complex charts have been omitted.

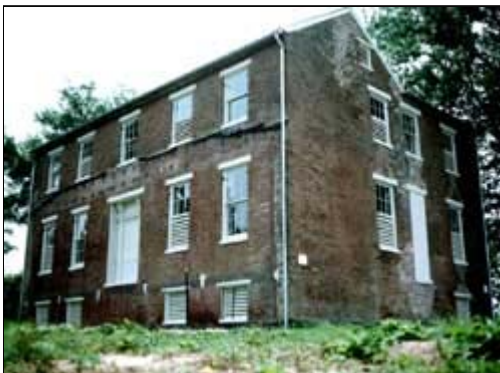
This building has been successfully mothballed for 10 years because the roof and walls were repaired and structurally stabilized, ventilation louvers added, and the property maintained. Photo: NPS files.

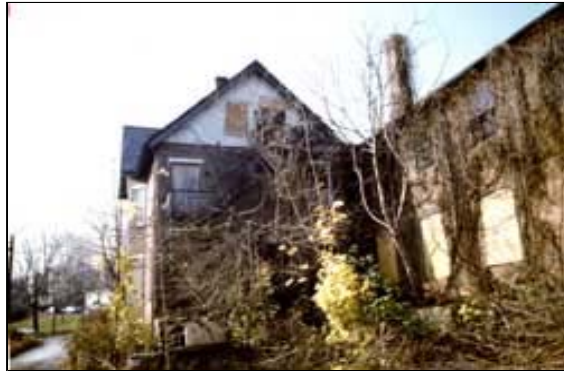
Boarding up without adequate ventilation and maintenance has accelerated deterioration of this property. Photo: NPS files.

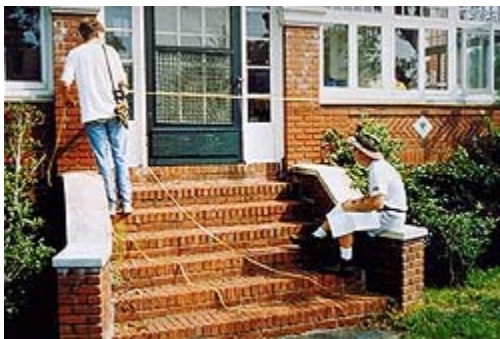
Documenting a building's history and assessing its condition provide information to set priorities for stabilization and repair, prior to mothballing. Photo: NPS files.

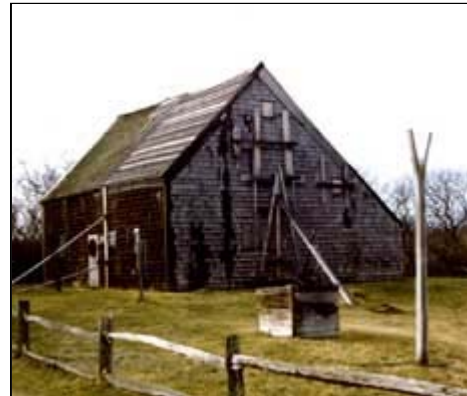
Buildings seriously damaged by storms or deterioration may need to be braced before architectural evaluations can be made. Photo: John Milner Architects. Photo: NPS files

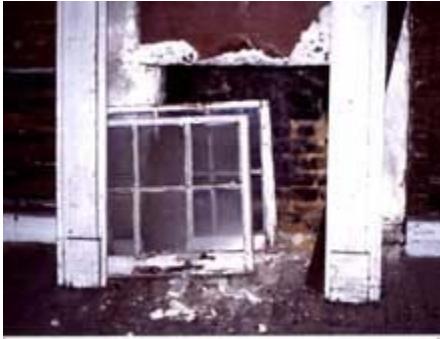
Loose or detached elements should be identified, tagged and stored, preferably on site. Photo: NPS files

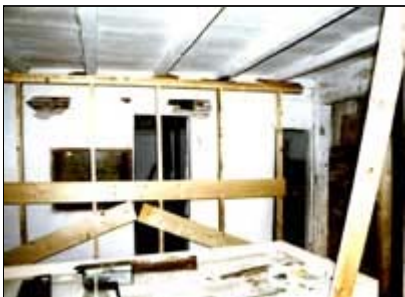
Interior bracing which will last the duration of the mothballing will protect weakened structural members. Photo: John Milner Architects.

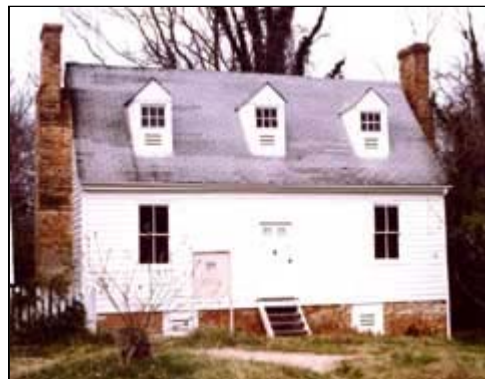
Regrading has protected this masonry foundation wall from excessive damp during its 10-year mothballing. Note the attic and basement vents, temporary stairs, and interpretive sign. Photo: NPS files.

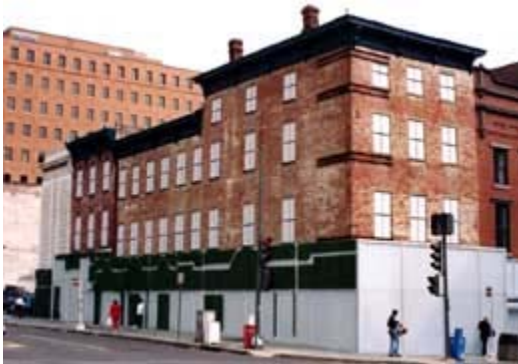
Urban buildings often need additional protection from unwanted entry and graffiti. This commercial building uses painted plywood panels to cover its glass storefronts. The upper windows on the street sides have been painted to resemble 19th century sash. Photo: NPS files.

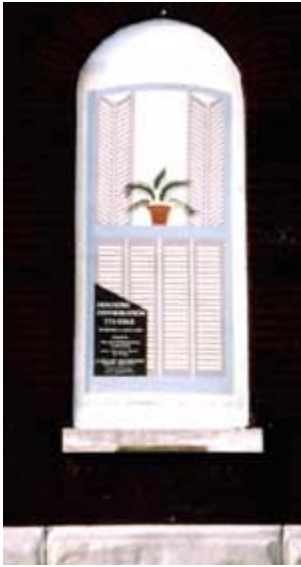
This painted trompe l'oeil scene on plywood panels is a neighborhood-friendly device. Photo: NPS files.

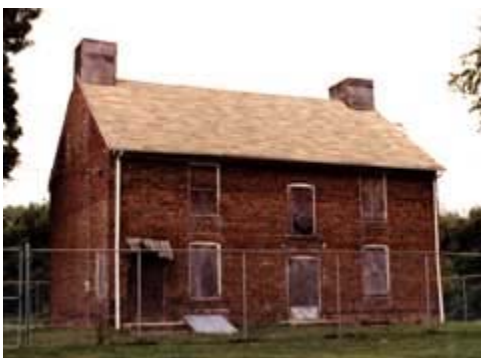
A view showing the exterior of the Brearley House, New Jersey, in its mothballed condition. Photo: Michael Mills, Ford Farewell Mills Gatsch, Architects.

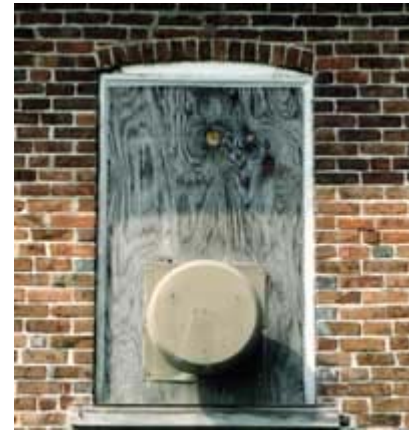
This exhaust fan has tamper-proof housing. Photo: Michael Mills, Ford Farewell Mills Gatsch, Architects.

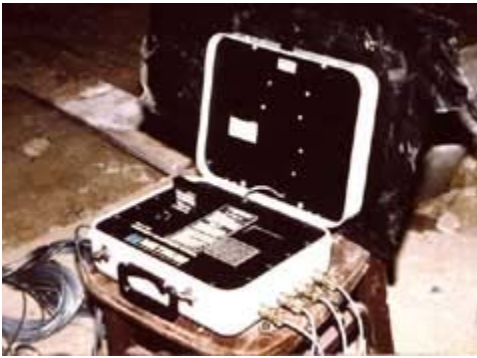
Portable monitors are used to record temperature and humidity conditions in historic buildings during mothballing. Photo: NPS files.
